Watershed Restoration FACTSHEET:

Joseph's Branch Project

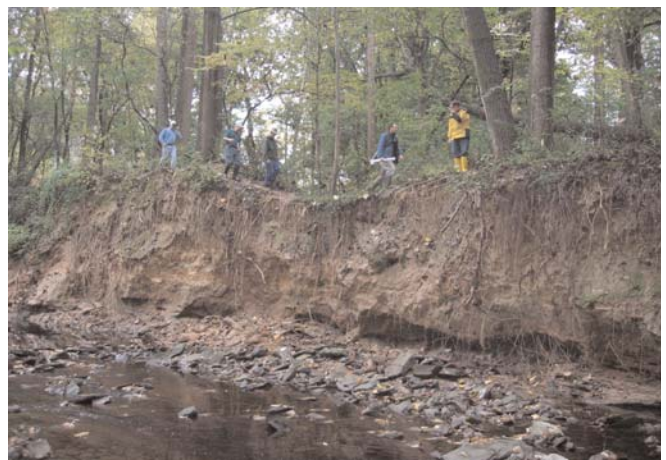
Pre-restoration conditions included severely eroded stream banks, undercut trees, limited habitat features, and exposed utilities

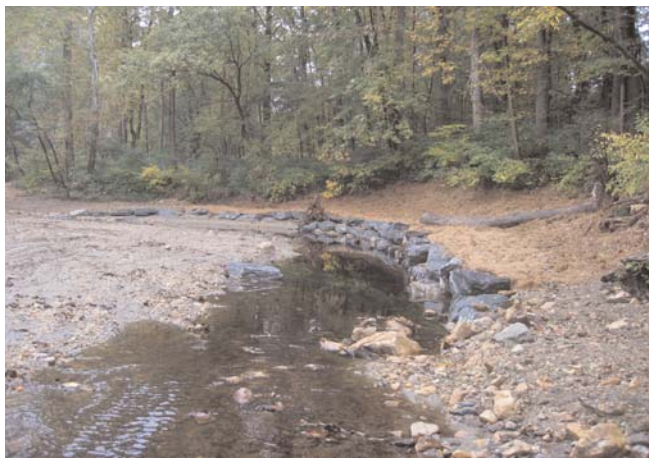
Boulder rock stabilizes the toe of the stream bank slope and creates a new floodplain terrace. Native riparian trees and shrubs planted above the rock will provide long-term bank stability

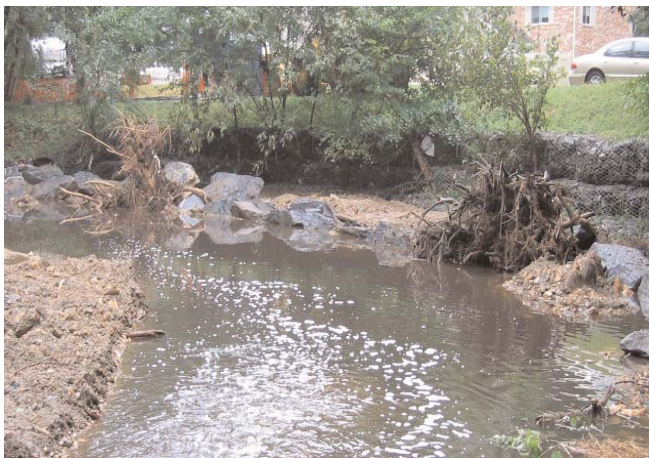
Root wad revetments, located on the outside of a meander, help stabilize the bank and create habitat and cover for aquatic insects and fish.
